Channahon, IL Detention Basin Erosion Mitigation

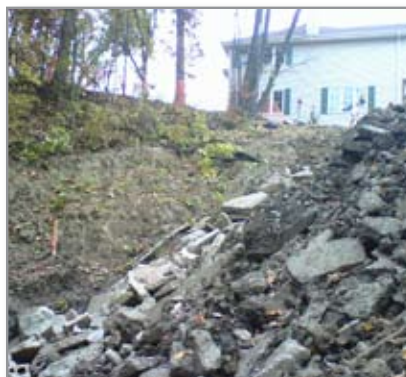
Stormwater runoff from the site was routed through several detention ponds, which concentrated what had been mainly sheet flows from farm fields into small sewers. The sewers discharged into the heads of natural ravines on the bluff, where erosion began to eat away at the ravines and adjoining banks. Adjacent homeowners were concerned about the steady loss of their property, and its potential impact on their homes. The Village was concerned about the undermining of adjacent public sidewalks and streets, and began placing broken concrete into the ravines to slow the erosion. This stopgap measure did not fully stabilize the soils underneath the concrete, and the erosion continued.

Erosion caused by stormwater runoff threatened nearby homes.

Baxter & Woodman, Inc. was hired to develop long-term solutions to the erosion dilemma. We examined the site, the development plans and supporting calculations, and proposed several alternative solutions. The solutions ran the gamut from an all-natural solution, using reinforced earth slopes planted with native grasses, to fully-armored concrete reinforcement. After reviewing the alternatives with the Village, a hybrid solution was selected using articulated concrete mats tied into the underlying soils, interlocking concrete jacks, and turfgrass for restoration.

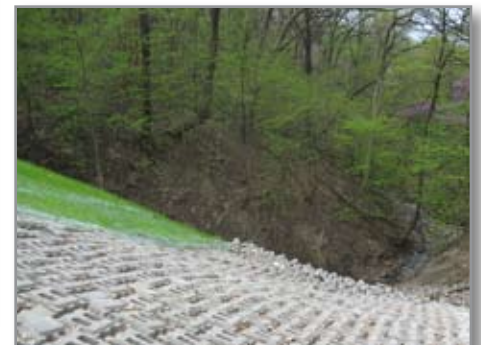
Turfgrass restoration over articulated concrete mats and interlocking concrete jacks stabilized the slopes.

Rather than full concrete reinforcement, erosion control was accomplished through a combination articulated concrete mats tied into the underlying soils and interlocking concrete jacks. Final restoration was accomplished with turfgrass.

The site has been fully restored. The Village is pleased that the grass has taken hold and the slopes are stable reducing the threat of damage to public and private infrastructure. The overwhelming success of this restoration project has led the Village and Baxter & Woodman to work together to implement a similar solution for another problem area in the same subdivision.
